Blown Film Mill

Atlanta, Georgia

CX-2

SOS# GA1234

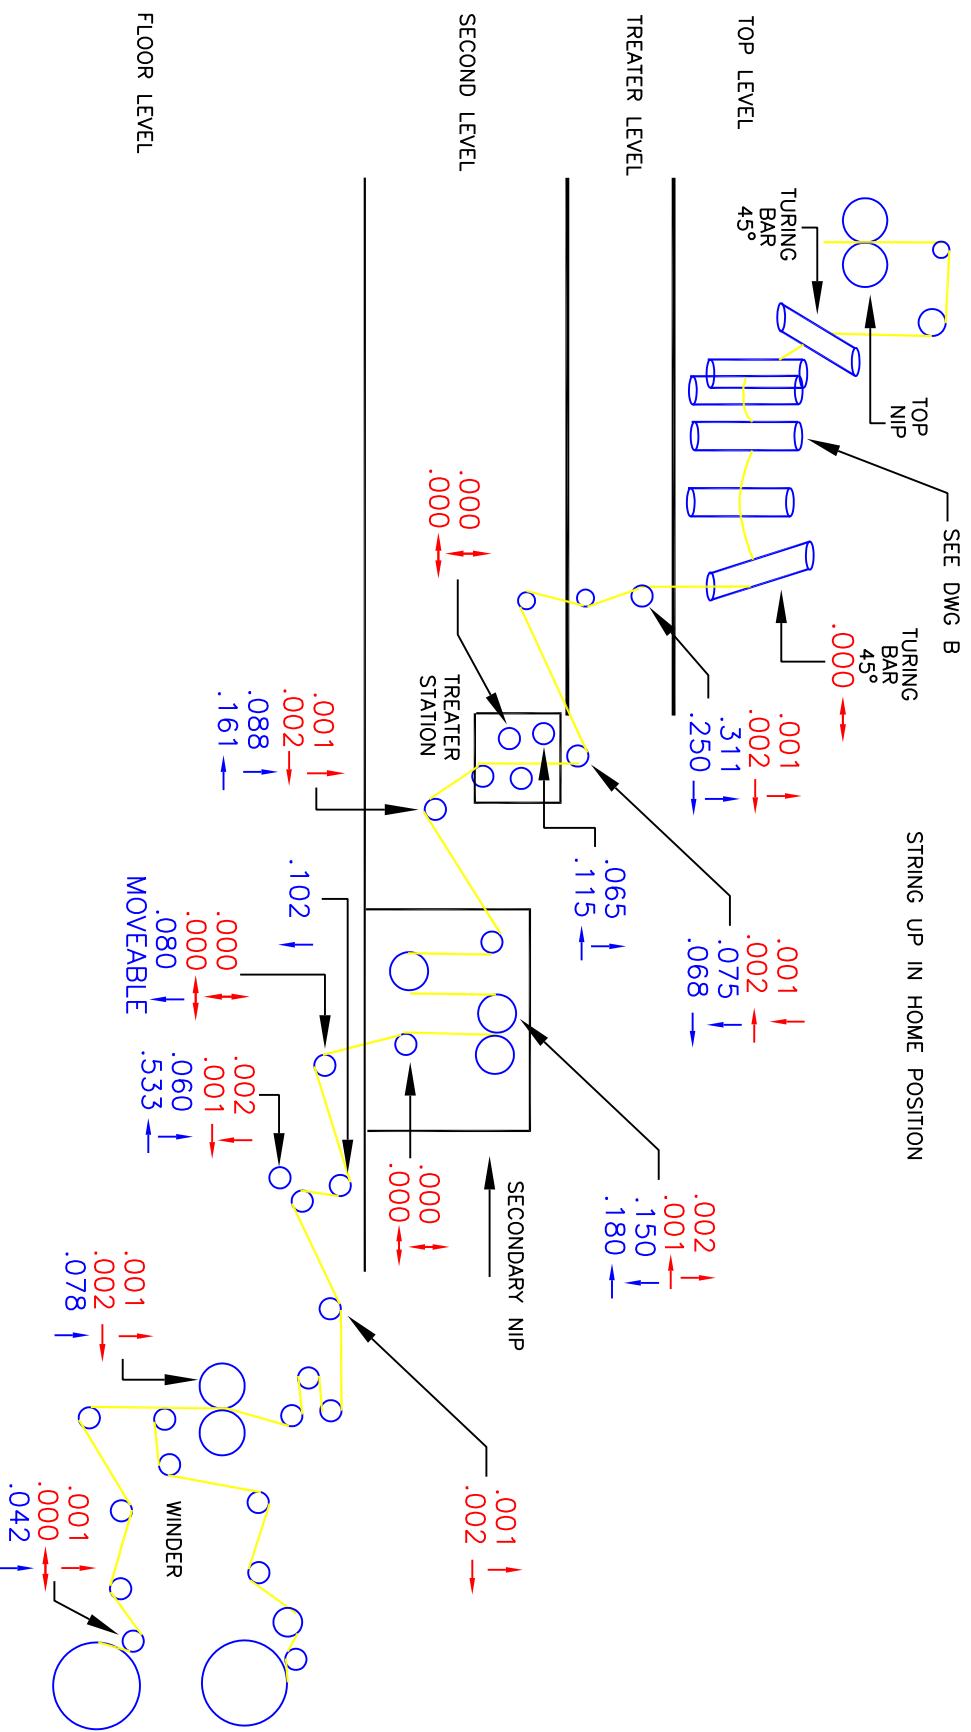
- ◆ SOS inspected all components for level and parallel. Results of these inspections can be seen on drawing GA1234A.
- ◆ SOS inspected the rotating element of the Primary Nip. Only two of thirty jacking bolts were touching. This caused the table level to fluctuate greatly during rotation. This also caused the pulsating wrinkling coming out of the nip, as the nip would be level for a brief period during its rotation. See drawing GA1234B for the before and after results.
