Paper Machine Sample Report

No. 3 Paper Machine

DRYER SECTION INSTALLATION & MACHINE PROFILE

SOS# GA0020

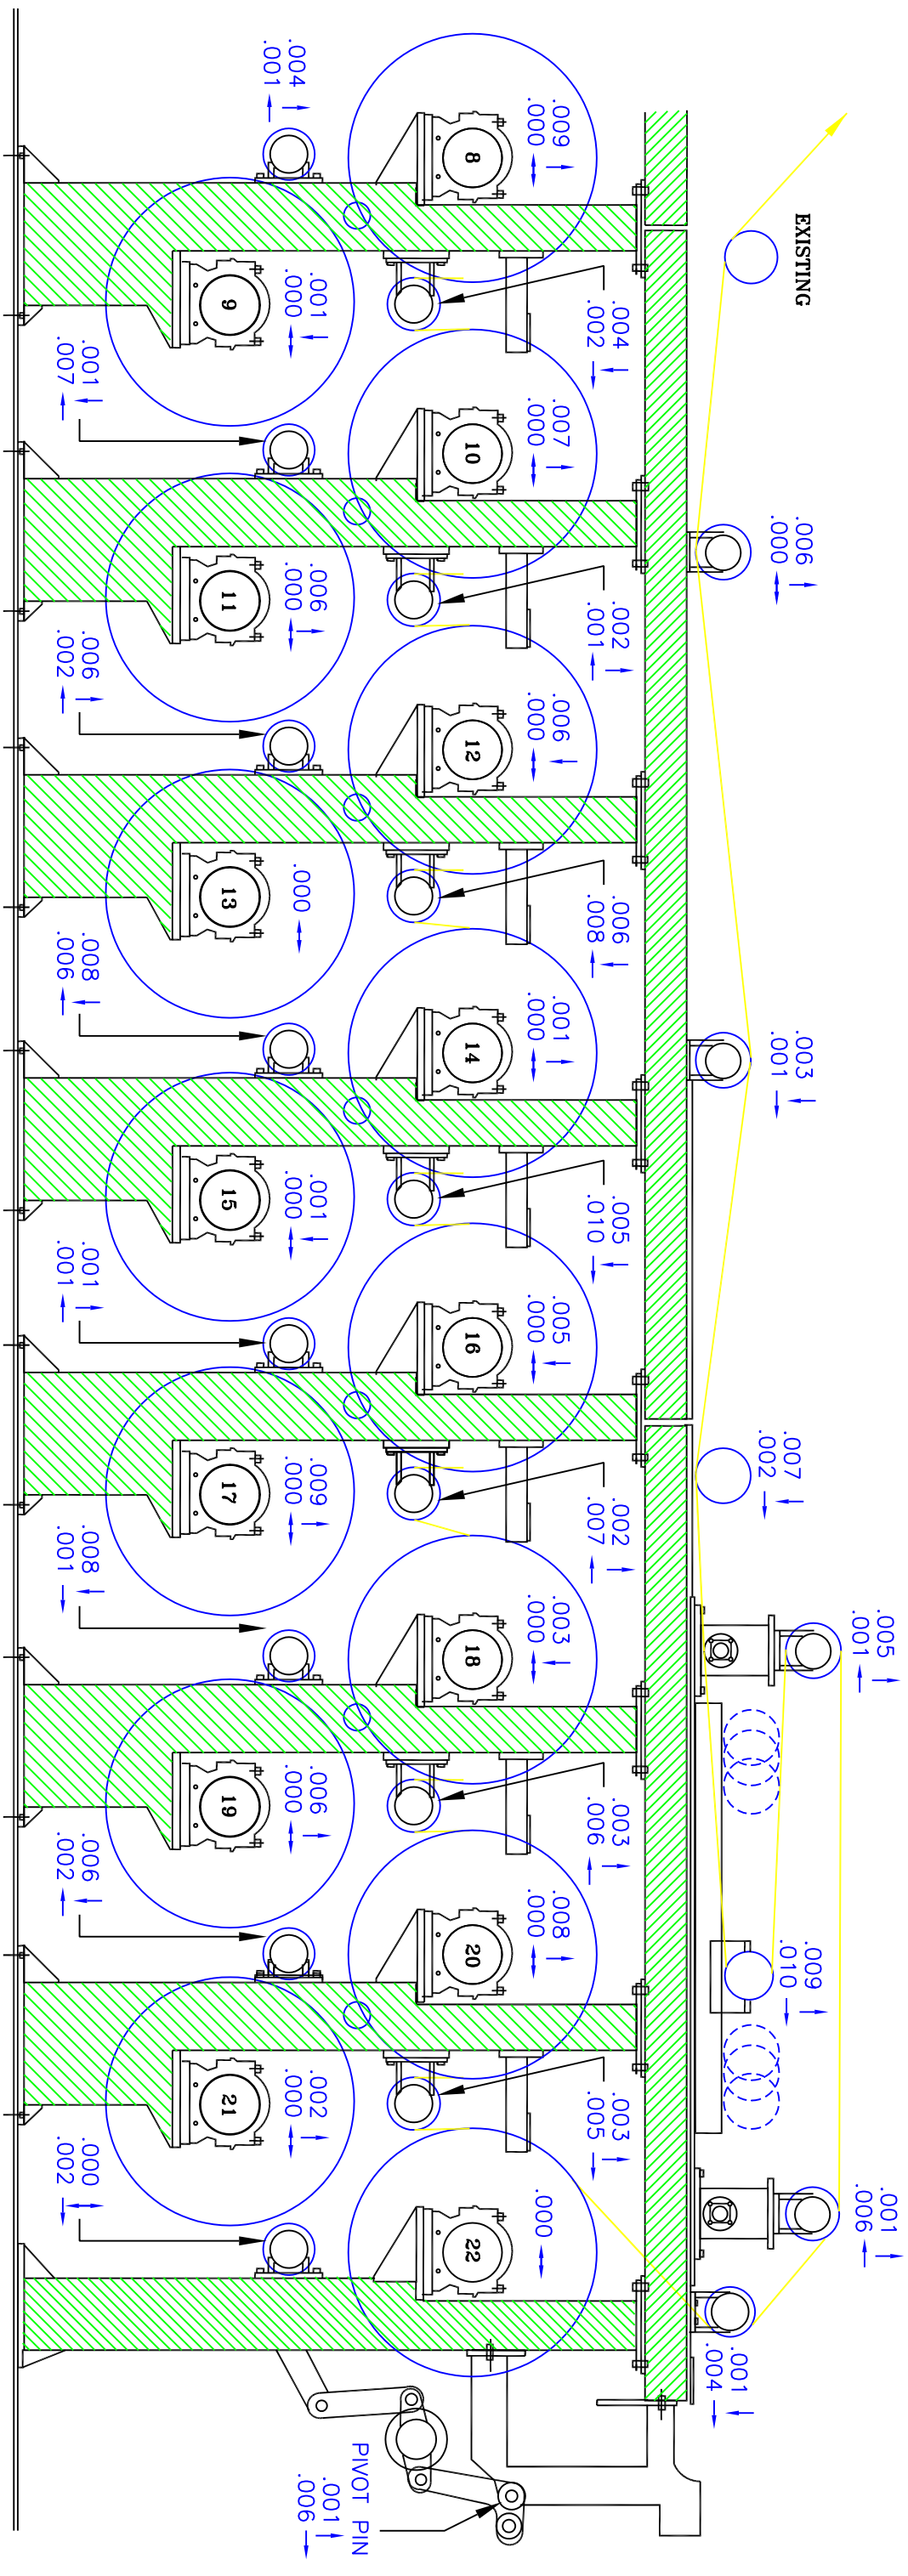
SOS FILE NO. GA0020A
 DATE: 5/19/00
 DRAWN BY: CCA

- ◆ The datum for the inspection of all rolls was the offset machine plug line. The level reference was gravity level.
- ◆ SOS inspected the existing plug line at the 1st Dryer Section, and it was not a true representation of the overall machine centerline. SOS corrected this plug line, as well as the other offset plug lines on this machine. SOS verified the new line, and these results can be seen on drawings GA0020E and F. Specific details can be seen in the plugline verification and recommendation portion of this report.

- ◆ SOS inspected the sole plates after they had been set by Mr. Jones and Mr. Edwards. The plates were within the acceptable tolerances.
- ◆ SOS then aligned the templates used for drilling the sole plates. The tending side templates were aligned in the cross machine and machine direction using the plug line as the parallel reference. The machine direction was placed on a specific dimension from an existing dryer can. The drive side templates were then placed on the correct dimension from the dryer can and gauged to the tending side templates. The templates pre-marked holes were then transferred to the sole plates by using a properly sized drill bit.

- ◆ SOS inspected all dryer cans for level after installation. No dryer cans required any shim.
- ◆ SOS inspected one dryer can in the bottom run and one in the top run for parallel. SOS then instructed a SOS millwright on mechanically aligning the remaining cans for parallel. The gear mesh on each dryer was set, then the tending side moved until proper alignment was achieved. The device used for this uses a .001” indicator, so proper tolerances can be held. SOS verified the correctness of all dryer cans and gear mesh.

- ◆ SOS inspected and corrected all pocket felt rolls for parallel. After parallel correction, SOS inspected and corrected all rolls for level.
- ◆ SOS inspected and corrected all upper felt rolls for level and parallel. SOS also corrected the Tension Roll’s pivot pins. All final data can be viewed on drawings GA0020A and B.

SOS recommends annual inspections of dryer section components. This detects potential problems before they cause unscheduled downtime, expensive repairs, and quality problems.
