## **Steel Mill Sample Report**

Steel Mill  
Alignment

03/15/00  
SOS# GA0015  
PO# 123456

**STRAIGHTLINE OPTICAL SERVICES INC.**

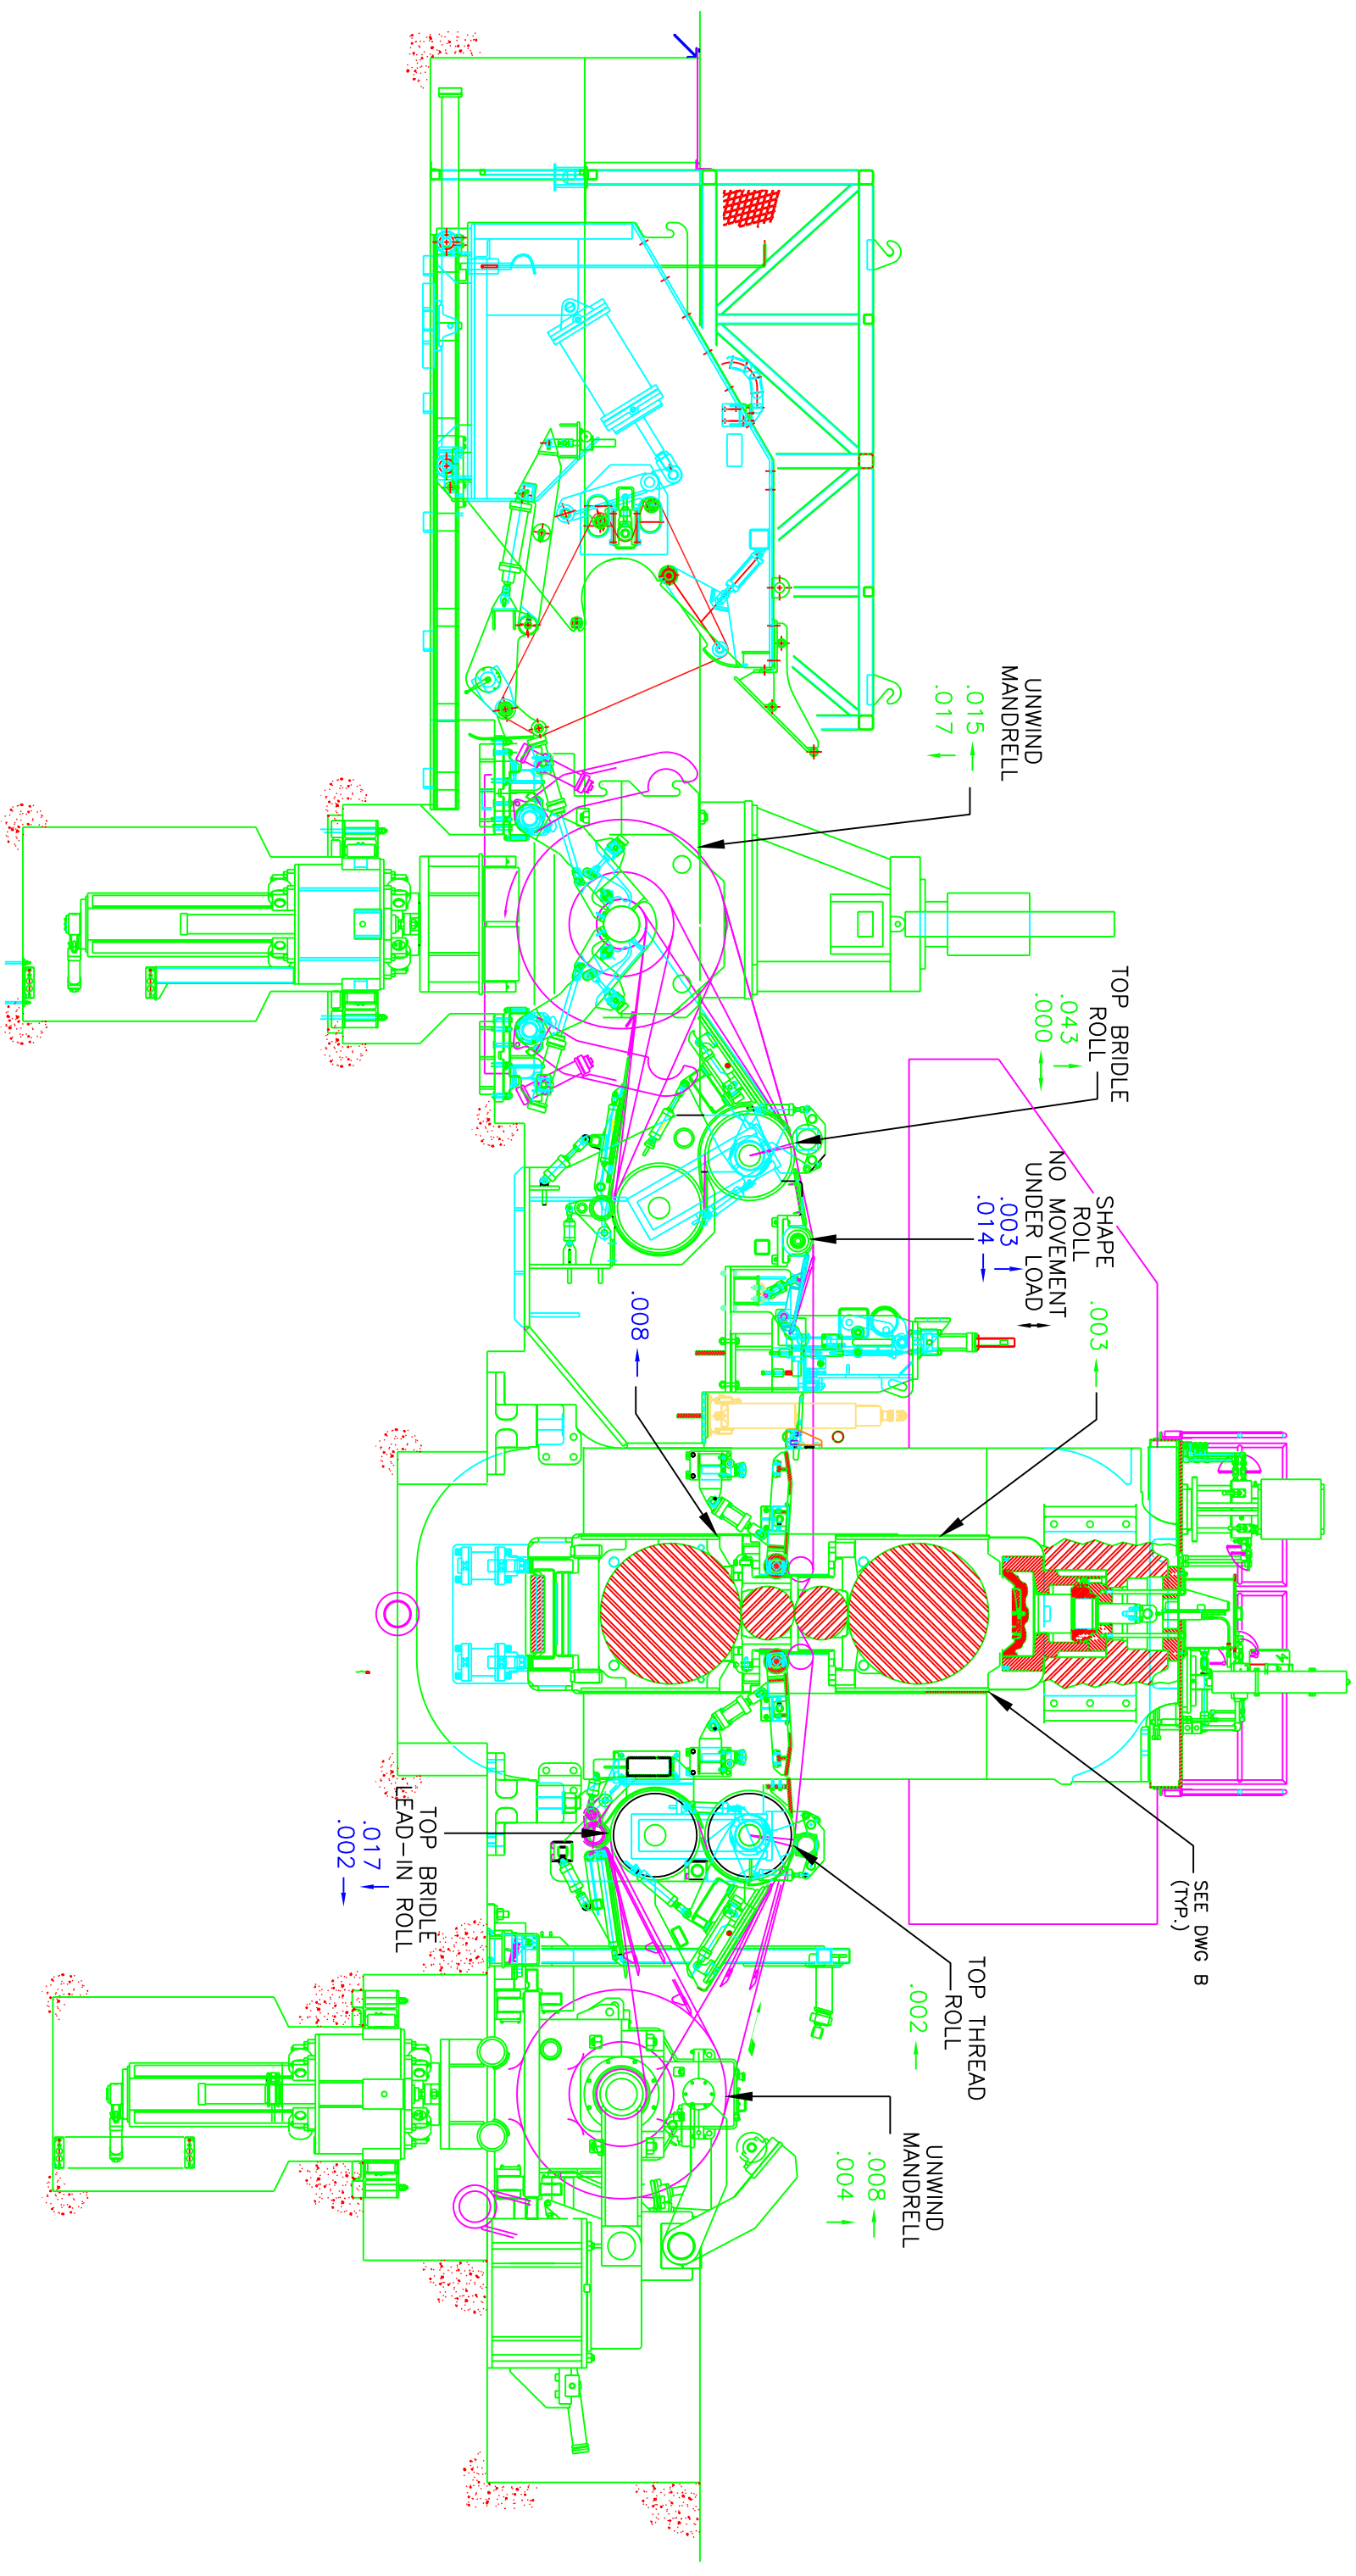
SOS FILE NO.  
GA0015A  
DATE: 3/16/00  
DRAWN BY: CCA

- ◆ The datum for the inspection of the rolls was the existing reference line on the operating side of the machine.
- ◆ SOS began the project by inspecting the static position of the Shape Roll on the Tandem Mill. The roll was found to be exactly square to the machine. SOS was then directed to observe the alignment of the roll during operation. This was performed by placing an optical alignment scale on the bearing housing and observing the *horizontal* movements of both the tending and drive sides. The tending side of the Shape Roll on the Tandem Mill was observed to move *horizontally* .016” towards the Unwind during operation. The drive side moved *horizontally* .008” to the Unwind during operation. The movement of the rolls in this direction is consistent with the direction the sheet contacts the roll.

- ◆ The static inspection of the Shape Roll on the Temper Mill found the roll .003” high in the front and .014” out of square. The roll was then inspected during operation to determine if any movement occurred under load. The inspection was performed by placing an optical alignment scale beside the bearing housing on both the tending and drive sides to observe any *vertical* movement. This was done due to the forces being exerted on the roll vertically. No movement was observed on the roll during operation.

- ◆ SOS was informed by Mr. Gilliland that the mill had discovered that the hold down bolts were not tight, resulting in movement in the roll alignment position.

- ◆ SOS discussed the possibility of shimming the front side of the Shape Roll on the Tandem Mill .008" to place the roll .008" out of square when static, which would make the roll operate at .000" given that the roll moves .008" more on the tending side during operation than on the drive side.
- ◆ SOS also feels that a further inspection be performed on the rolls in the mill to try and determine if alignment issues are partly responsible for the extremely loose edge observed by SOS during the operation of the mill. This inspection would include the Unwind and Rewind, as well as the work rolls. The inspection of the Unwind and Rewind should be performed both static and under load.
- ◆ SOS feels that the mounting surface of the 1st Stand Backing Roll should be inspected for level. This would help to determine if misalignment at the mounting surface is the root of the misalignment issues.

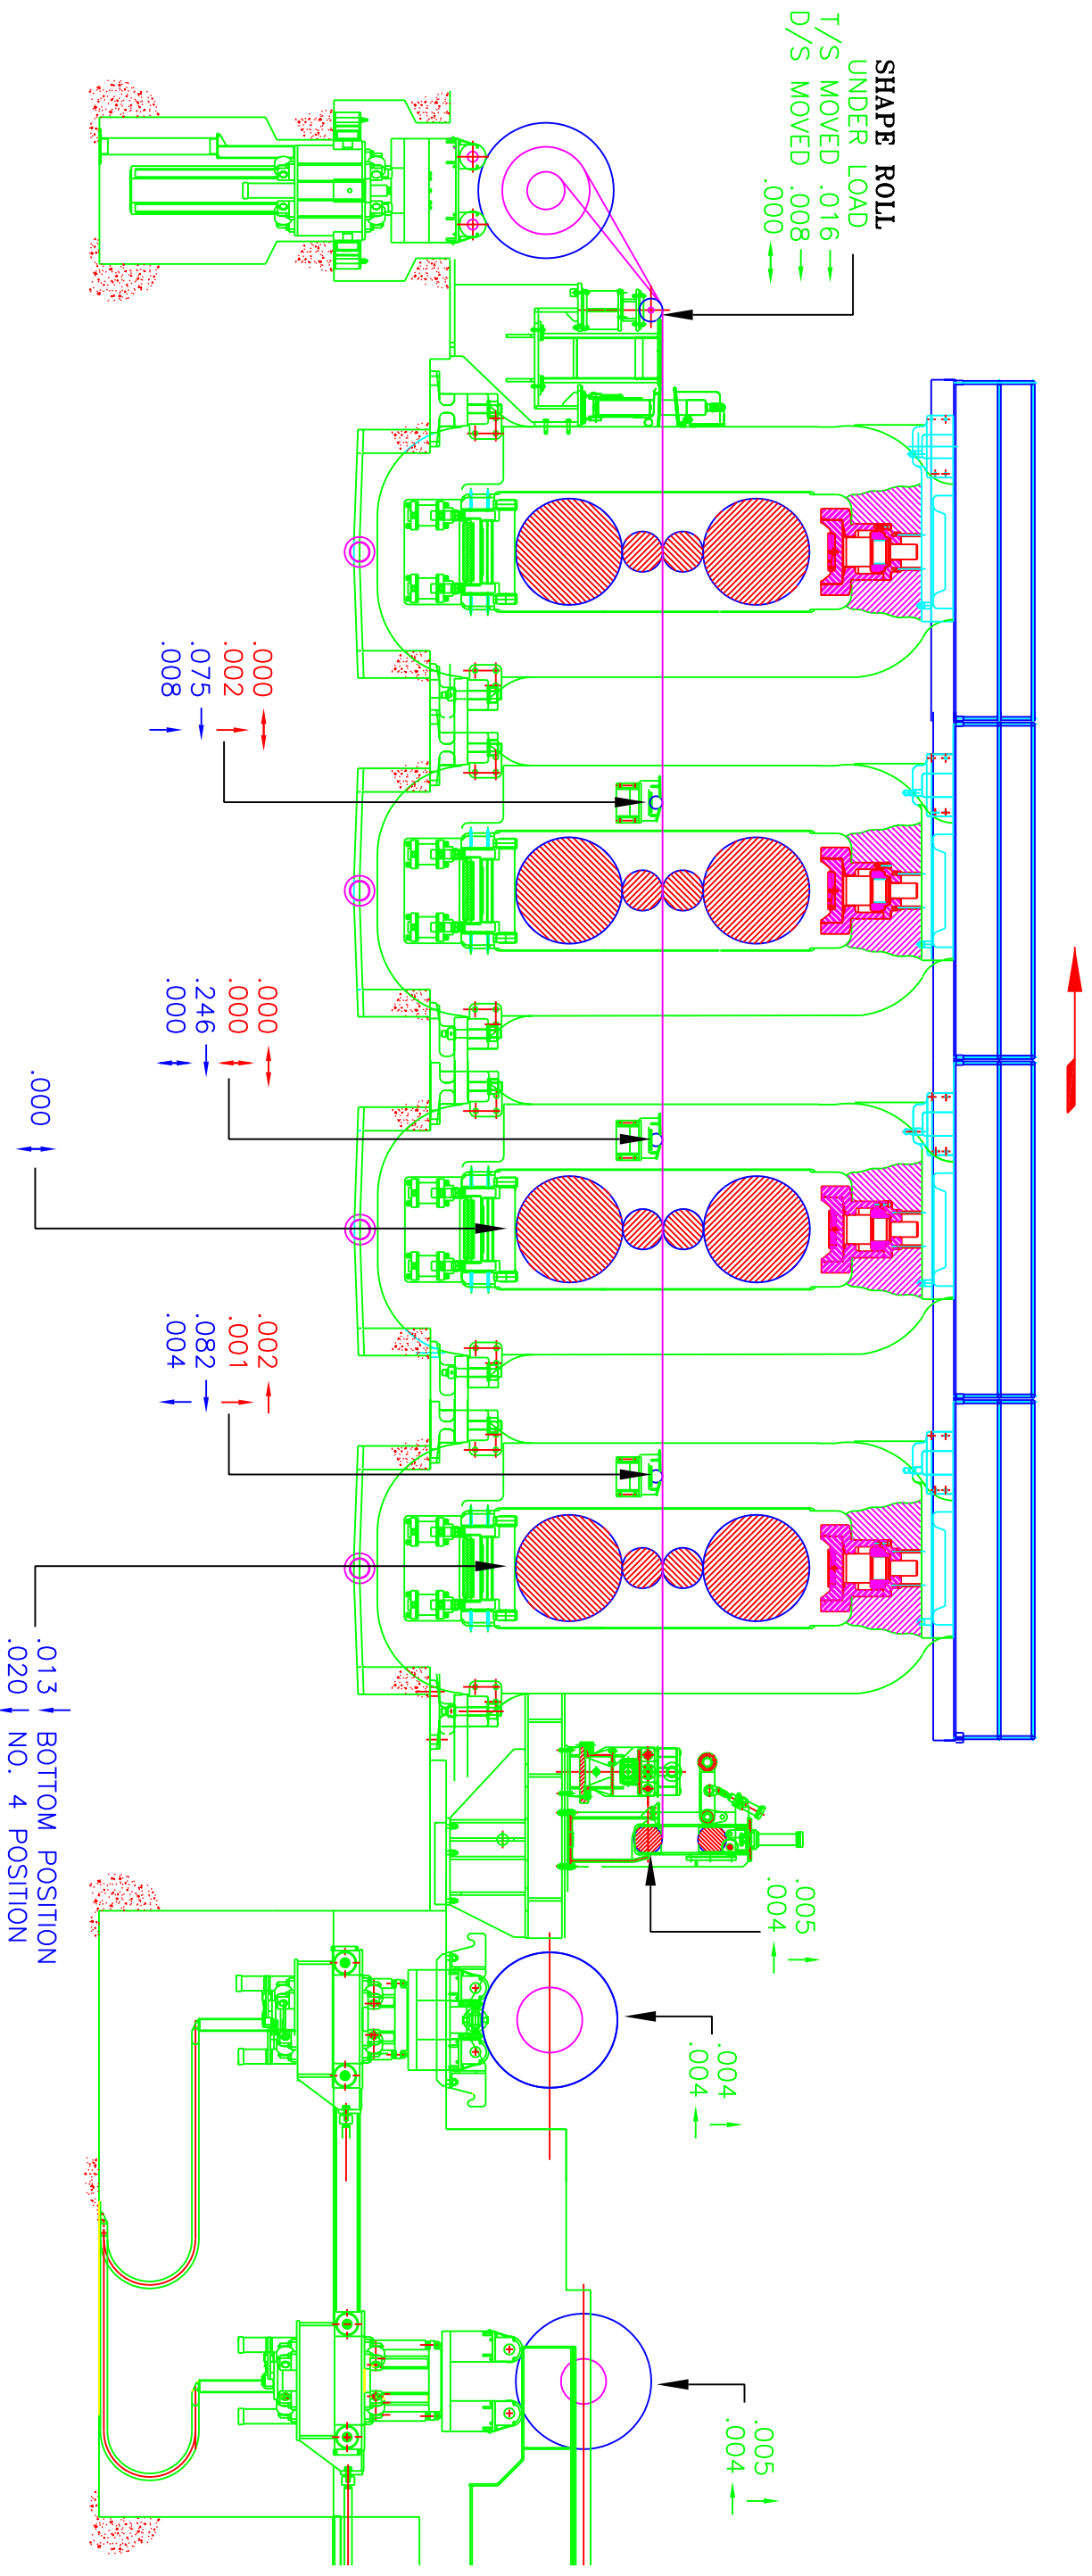
SOS FILE NO.  
GA0015B  
DATE: 3/16/00  
DRAWN BY: CCA

- ◆ SOS began the project by inspecting the static position of the Tensiometer Rolls. Following the inspections of the individual rolls, the alignment of the rolls was performed. The Tensiometer roll in 2nd Stand was found to have the most misalignment. This roll was found to be .246” out of square. The roll was corrected to be .000 due to the sensitive nature of the roll.

- ◆ The alignment of all of the rolls was held to +/- .002”. The results of the inspection can be seen on the following drawing No. GA0015B.
- ◆ SOS was directed to inspect the level of the 1st Stand and two bottom Backing Rolls. The inspection of the 2nd Stand Backing roll found the roll to be exactly level. The inspection of the 1st Stand Backing Roll found the roll to be .020” low in the front in the No. 4 position.
